The case study of a brittle failure of a mountain bike frame composed by carbon fiber reinforced plastic

A mountain bike carbon reinforced polymeric frame failed in two pieces during cycling over a grass meadow at a speed of about 25 km/h. This has caused the shoulder dislocation of the driver, also last author of this paper. Here, we demonstrate evidence of macroscopic numerous pre-existing and propagating defects, such as wrinkles, voids and delaminations, resulting in low mechanical properties of this frame. Numerical dynamic simulations conclude the paper and suggest a further cause of frame weakening, due to defect-resonance interaction. The paper suggests that the design of carbon fiber reinforced plastic frame for mountain bikes may require new scientific and technological advancements for the safety of the riders, at least today carefully eliminating pre-existing defects and tomorrow proposing bioinspired flaw tolerant solutions.

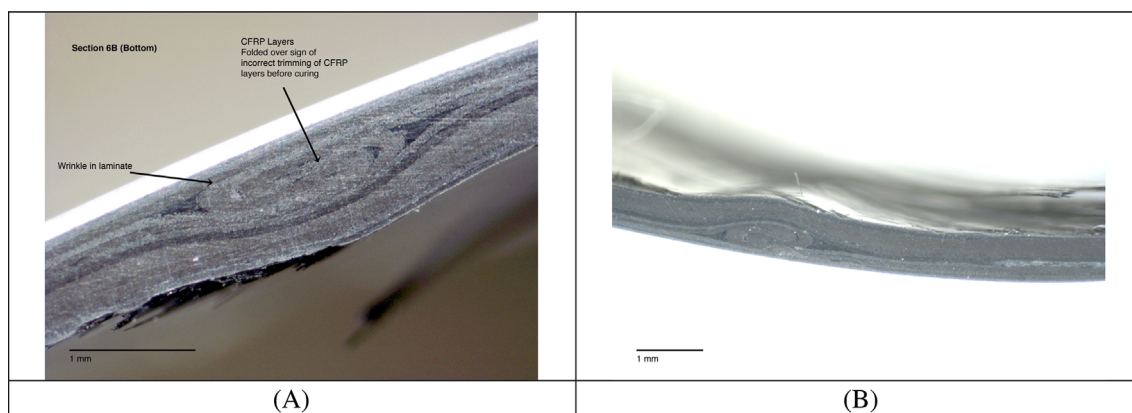
Numerous instances of severe wrinkling are discovered from the micrographic inspections. Figure 5 shows a large wrinkle in two of the sections from the top tube. The presence of large amounts of out-of-plane wrinkling (or fiber waviness) point to poor handling of the plys during the ply cutting and collation process. The oversized plys appear to have been mishandling during the collation process in the tool leading to the wrinkle defects. The wrinkle defects found in multiple locations on the bike frame fall under the category of severe wrinkling defects not acceptable for high performance composite applications where good dynamic, fatigue and static strength performances are desired.

The acceptable industry practices on fiber waviness typically tolerate low amounts of fiber wrinkling based on the waviness aspect ratio. A wrinkle aspect ratio (length divided by height) greater than 15 is considered acceptable. As the aspect ratio approaches infinity the ply is considered perfectly straight while an aspect ratio below 15 indicates severe impact on the composite design. The wrinkle in Figure 5A does not only have an aspect ratio of

approximately 8 but is also coupled with the load path being completely disrupted by the folding over for 2 plys. A similar defect from another section is also shown for comparison in Figure 5B. It is important to note that the wrinkle from 6B appears to have run all the way across the tube to the front of the frame when observed at 6F. Large wrinkles are also observed in the cross-sectional scans in samples 2, 3, 4, 5, and 6. In many cases the same wrinkle extends through the multiple sections examined. Given the morphology of wrinkles observed, the static strength and stiffness in the areas around the wrinkling zone are expected to be more than 50% lower than pristine or unwrinkled portions away from this region and the fatigue life reduced by more than 10.^{1–36}

FIGURE 5 (A) Large wrinkle due to the carbon fiber reinforced plastic (CFRP) ply folding over during the ply collation process (Section 6B). (B) Large wrinkle in top tube in Sample 7F.

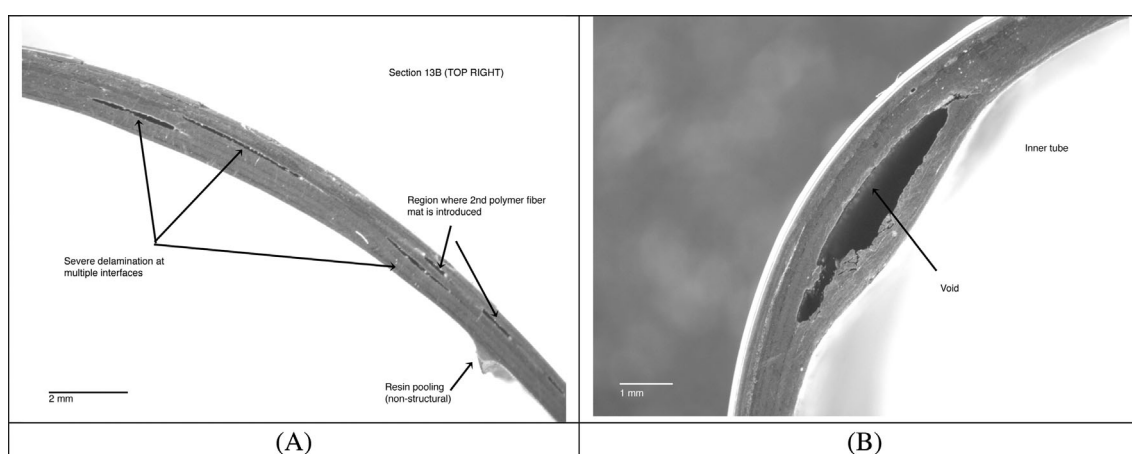
Every section of the frame examined contained multiple interfaces that are affected (Figure 6A). In one section near the fracture zone a large void is observed at the tube radii (Figure 6B). Curved parts are sensitive to the tooling, stacking sequence, part thickness and resin properties. Resin migration, disbonds, fiber waviness and porosity can all occur in the curved regions when improper processing takes place.⁴⁸ Other defects observed in the examined frame that are also associated with poor consolidation at the tube radii include blisters in the inner tube and non-uniform ply thicknesses or resin thinning.

Such macroscopic delaminations are even more critical than the previously observed wrinkles. The defects are so numerous, large and close that their interaction and further weakening is expected.

FIGURE 6 (A) Multiple delamination sites at various interfaces in Section 13B. (B) Large void due to improper consolidation in Section 7F.

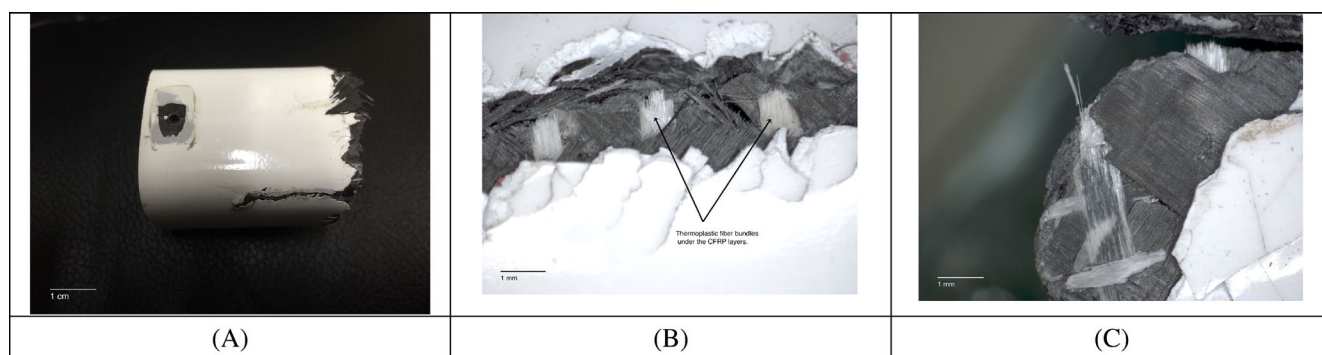
FIGURE 7 (A) Top tube fracture region (note this is the section adjacent to Sample 8 face b). See part (B) for close-up of fracture region. (B) Close-up of fracture zone in top tube showing thermoplastic fibers in failure region; note the thermoplastic fiber bundles are located within the carbon fiber reinforced plastic (CFRP) stack. (C) Close-up of region containing thermoplastic fiber mat.

appeared to be white colored filaments in the fracture zone (Figure 7A–C). The microstructural investigation confirms the presence of a 2nd material system directly present and impacting the structural performance of the

composite material beyond the carbon fiber and the polymeric resin. The filaments appear to be polymer fiber bundles and are in the form of a fiber mat that is present along the sides of the tubes (both top and down tubes).
