The case study of a brittle failure of a mountain bike frame composed by carbon fiber reinforced plastic

A mountain bike carbon reinforced polymeric frame failed in two pieces during cycling over a grass meadow at a speed of about 25 km/h. This has caused the shoulder dislocation of the driver, also last author of this paper. Here, we demonstrate evidence of macroscopic numerous pre-existing and propagating defects, such as wrinkles, voids and delaminations, resulting in low mechanical properties of this frame. Numerical dynamic simulations conclude the paper and suggest a further cause of frame weakening, due to defect-resonance interaction. The paper suggests that the design of carbon fiber reinforced plastic frame for mountain bikes may require new scientific and technological advancements for the safety of the riders, at least today carefully eliminating pre-existing defects and tomorrow proposing bioinspired flaw tolerant solutions.

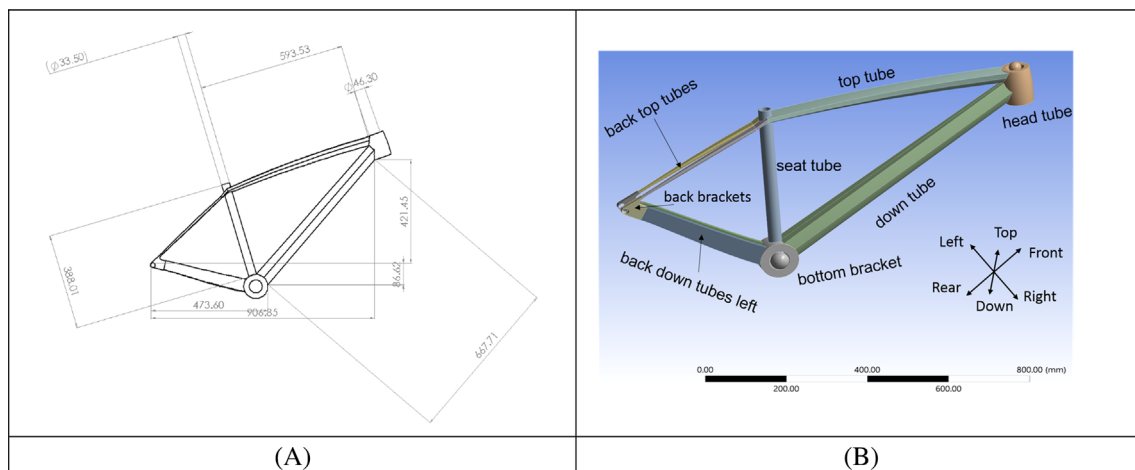
FIGURE 9 (A) Geometries (sizes in mm) considered in the numerical simulations. (B) Adopted nomenclature.

Note: Values were measured on the real frame (see Figure 9 for the definition of the orientation vectors).

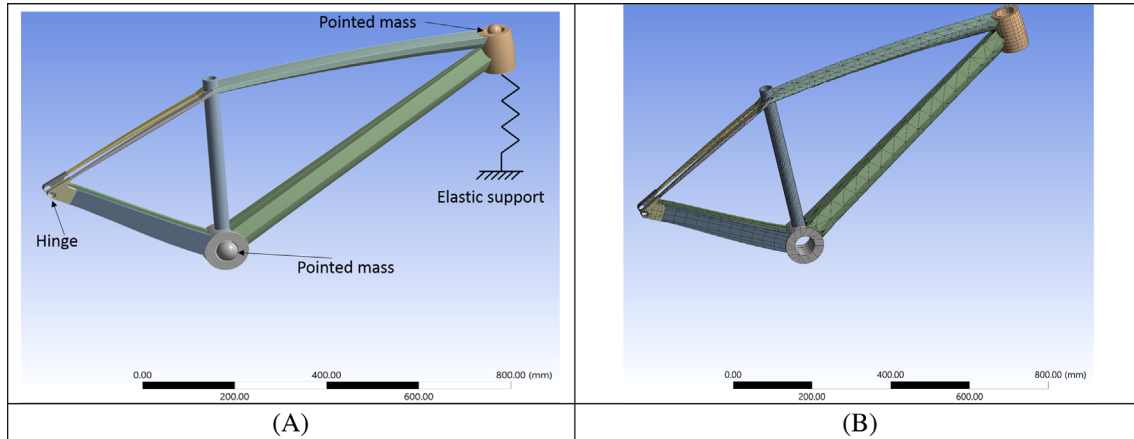
**FIGURE 10** (A) Applied boundary conditions. (B) Adopted mesh.**TABLE 5** Properties of the pointed masses.

fork is $A = 2.18 \times 10^{-3} \text{ m}^2$ thus as $K_f = K/A$ (Table 8). Figure 10B and Table 9 report the adopted mesh. The computed natural frequencies are reported in Table 10 and, due to the driver position/man mass real distribution and measured low elastic modulus, are observed quite low, from 3 up to 111 Hz for the first 6 modes, Figure 11A–F. Note that mode 4 has a frequency around 68 Hz and is thus compatible with a resonance imposed by the wavy nature of the grass and cycling velocity (previously computed as 69 Hz); also note that the related mode shape (Figure 11D) has the maximal relative displacement in the region of the observed fracture. We cannot thus exclude that the observed severe defects were further weakened by interaction with a dynamic resonance.
